Geotechnical Evaluation

Joan MacQueen Middle School Field Renovation

2001 Tavern Road
Alpine, California

February 17, 2020 | Project No. 108464009

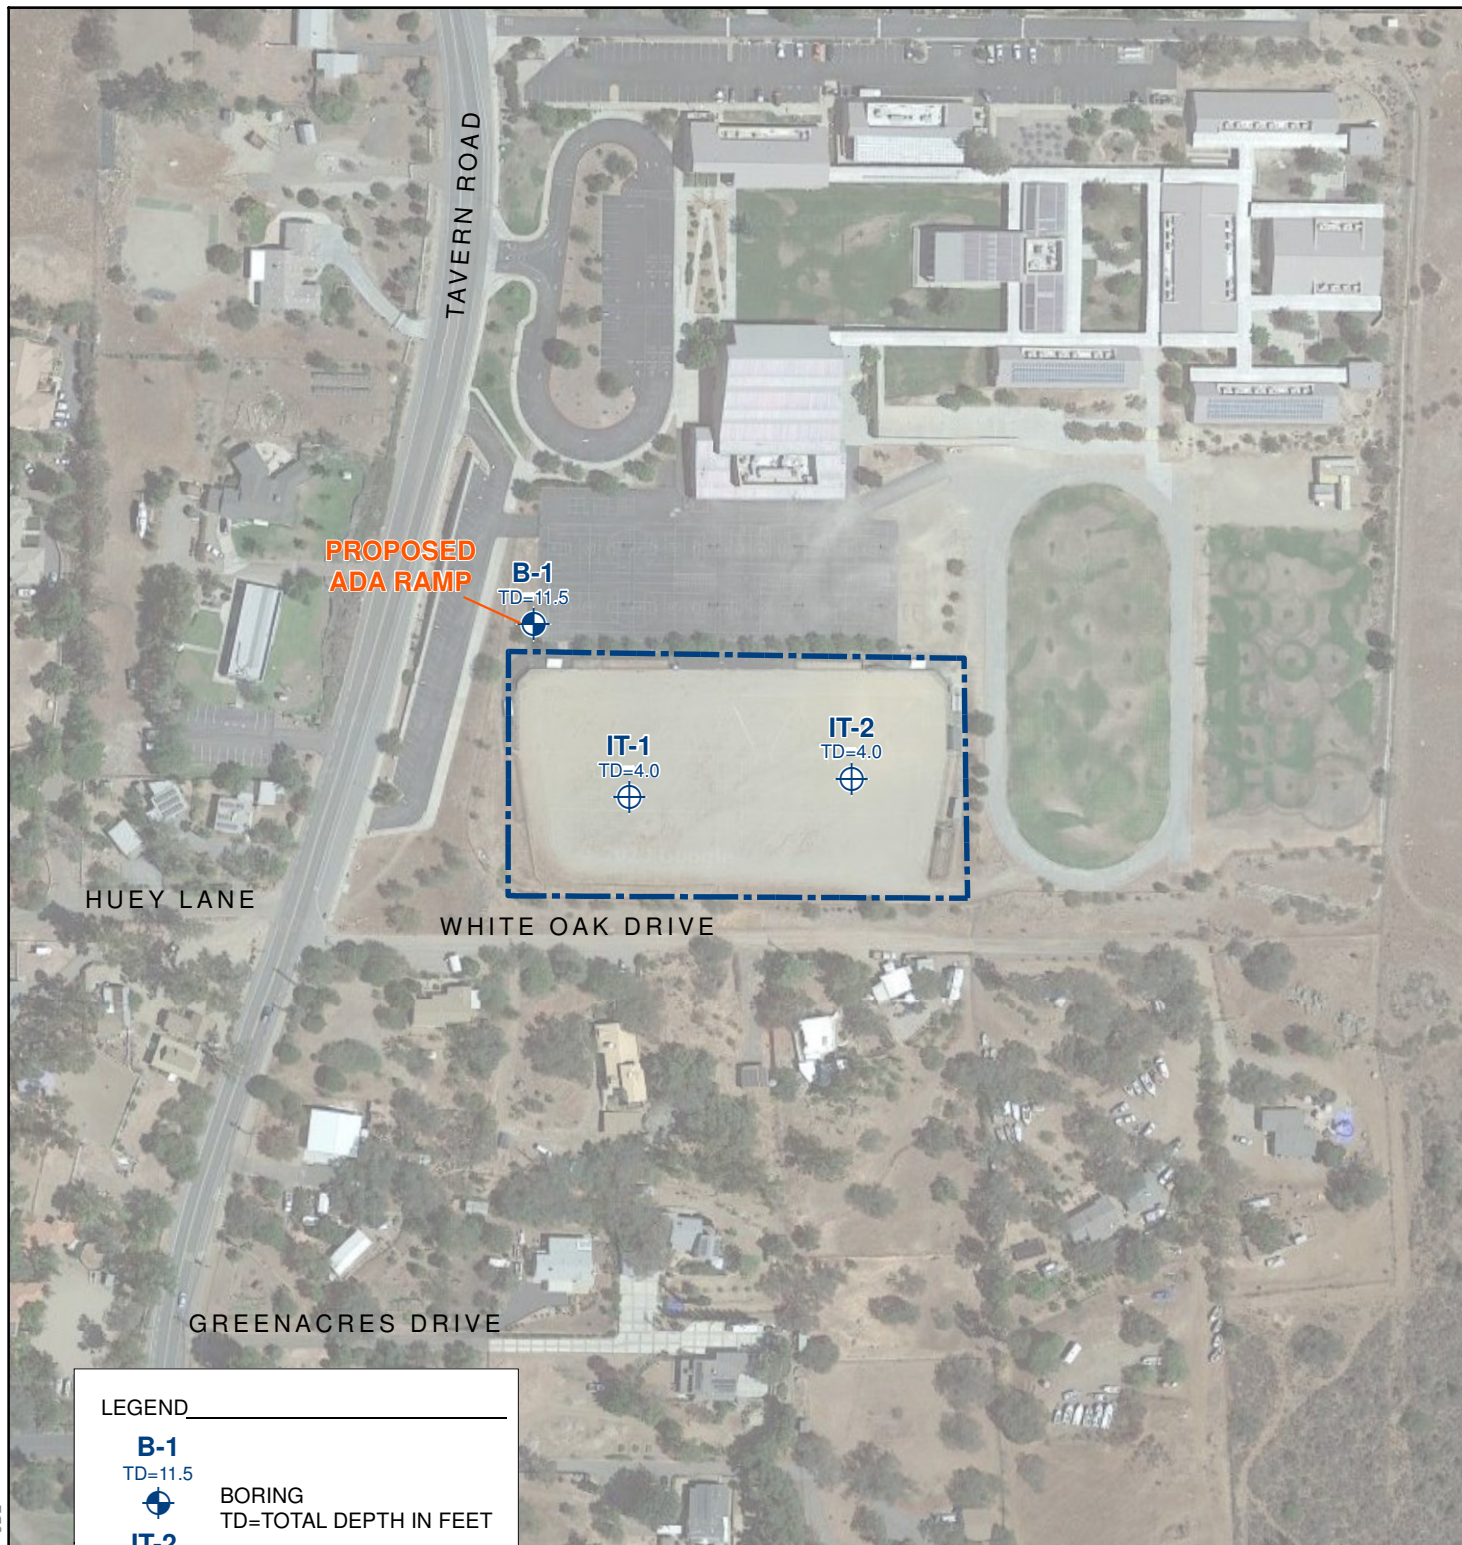
BORING LOCATIONS

B-1
TD=11.5

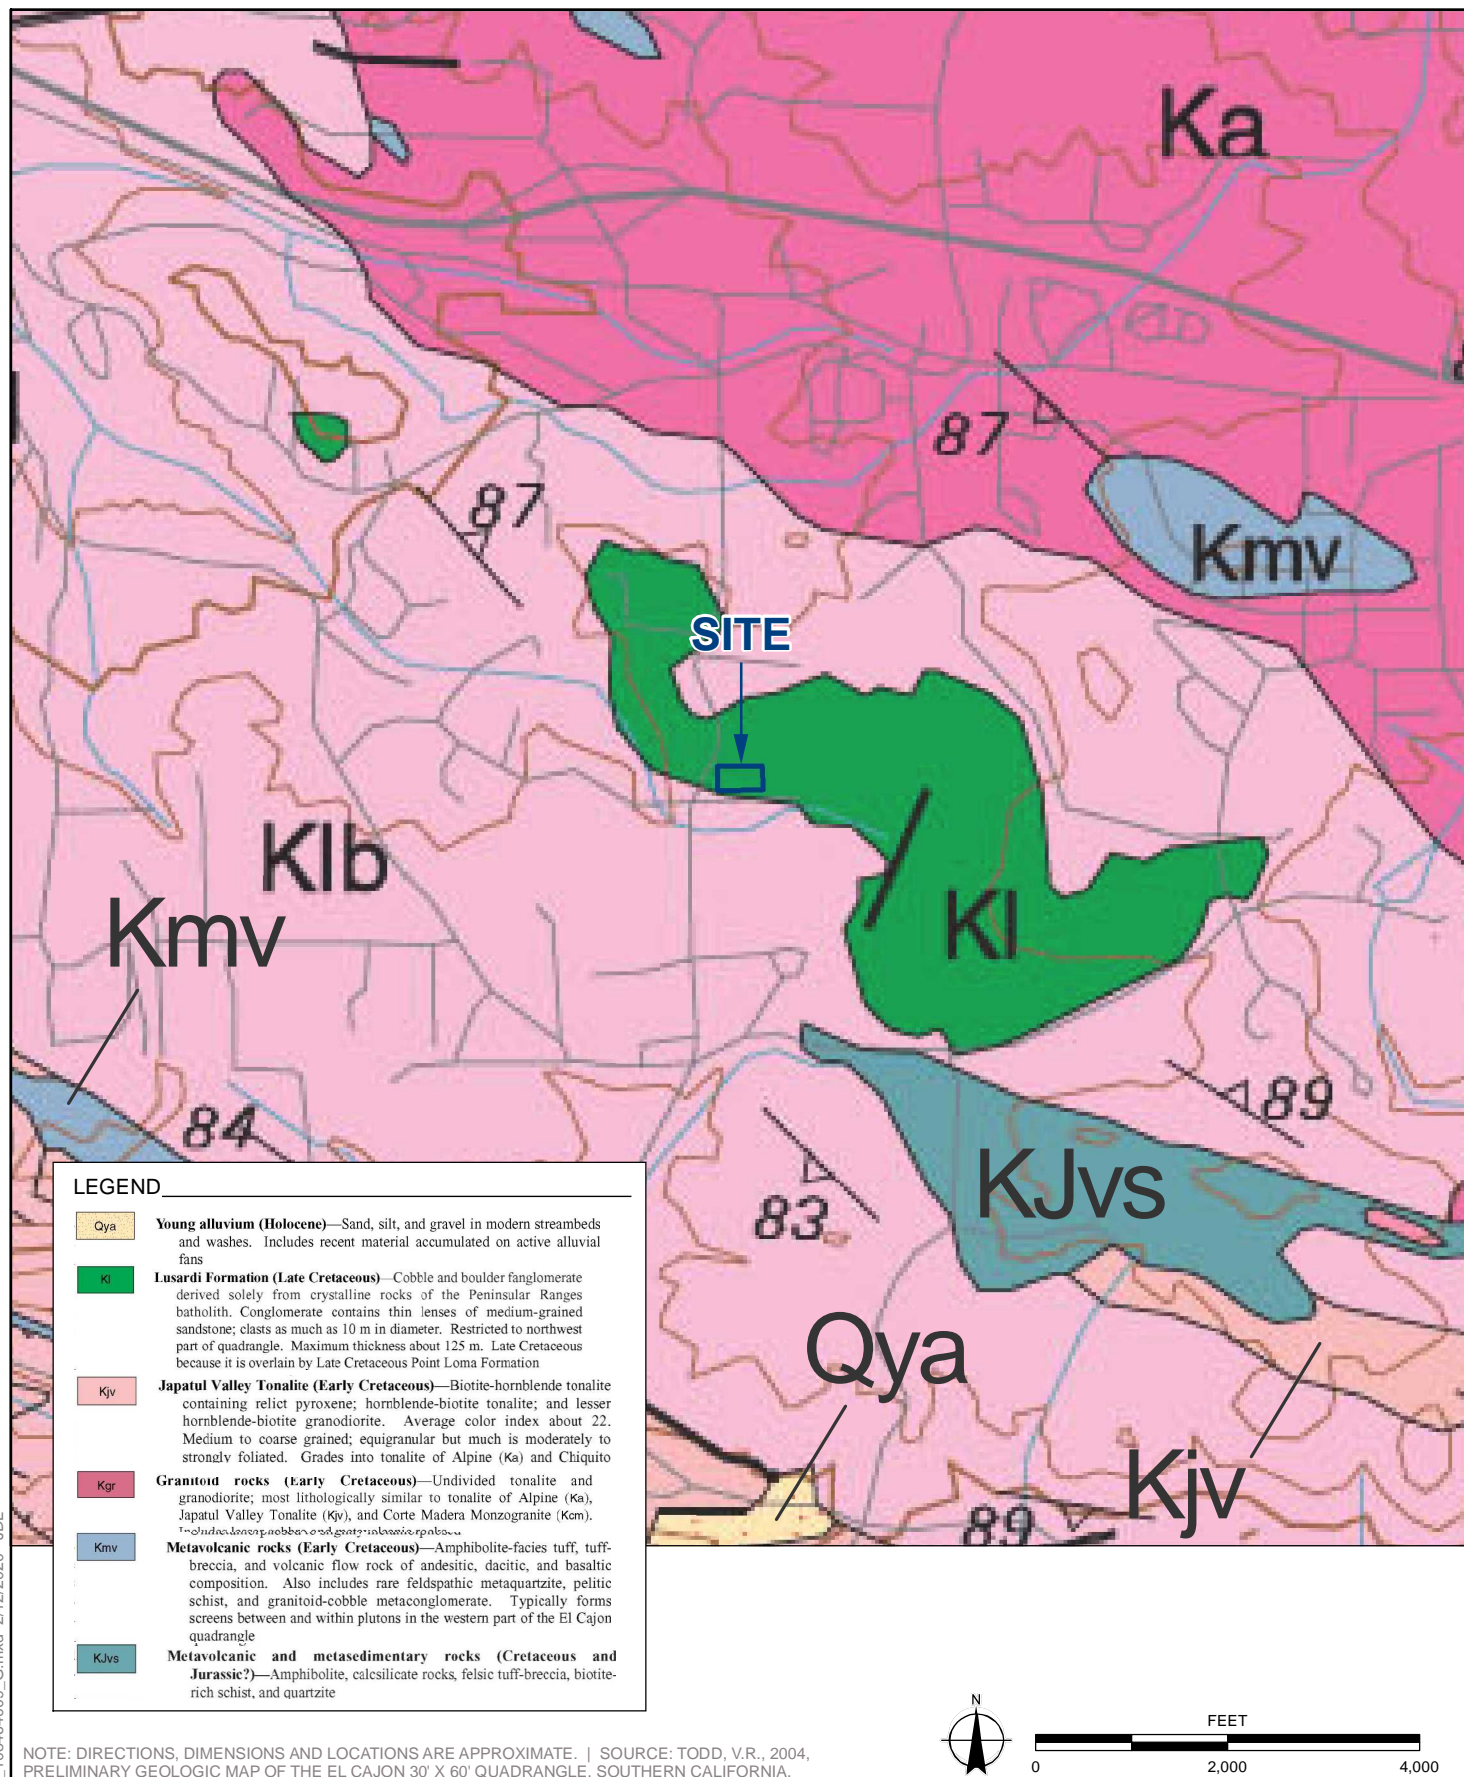
FIGURE 4

GEOLOGY

Geologic units encountered during our subsurface exploration included fill soils and colluvium. The site is mapped as being underlain by the Cretaceous-age Lusardi Formation (Todd, 2004; Figure 4). Generalized descriptions of the earth units encountered during our subsurface exploration and those mapped at the site are provided in the subsequent sections. Additional descriptions of the subsurface units are provided on the boring logs in Appendix A.

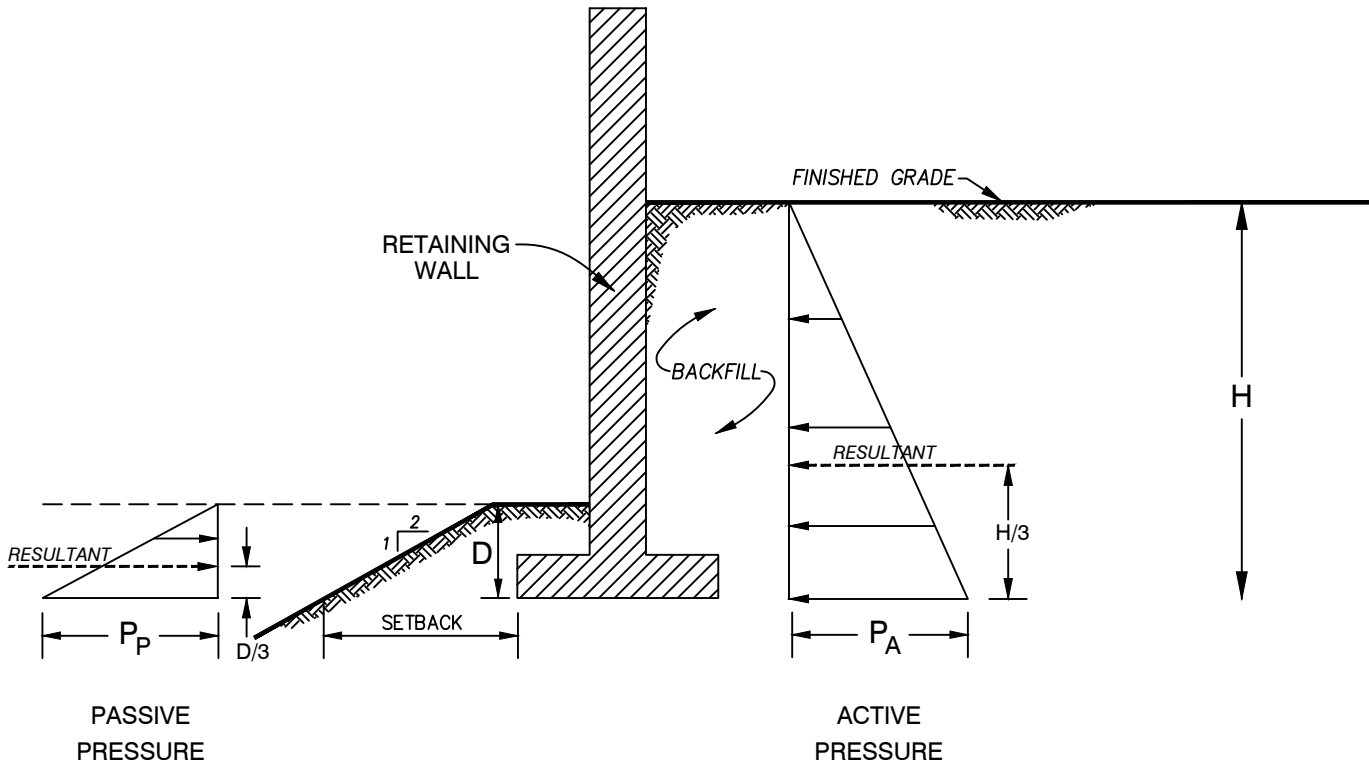
LATERAL EARTH PRESSURES FOR YIELDING RETAINING WALLS

1. ASSUMES NO HYDROSTATIC PRESSURE BUILD-UP BEHIND THE RETAINING WALL
2. GRANULAR BACKFILL MATERIALS SHOULD BE USED FOR RETAINING WALL BACKFILL
3. DRAINS AS RECOMMENDED IN THE RETAINING WALL DRAINAGE DETAIL SHOULD BE INSTALLED BEHIND THE RETAINING WALL
4. SURCHARGE PRESSURES CAUSED BY VEHICLES OR NEARBY STRUCTURES ARE NOT INCLUDED
5. H AND D ARE IN FEET
6. SETBACK SHOULD BE IN ACCORDANCE WITH THE CBC
7. COEFFICIENT OF FRICTION, $\mu = 0.2$

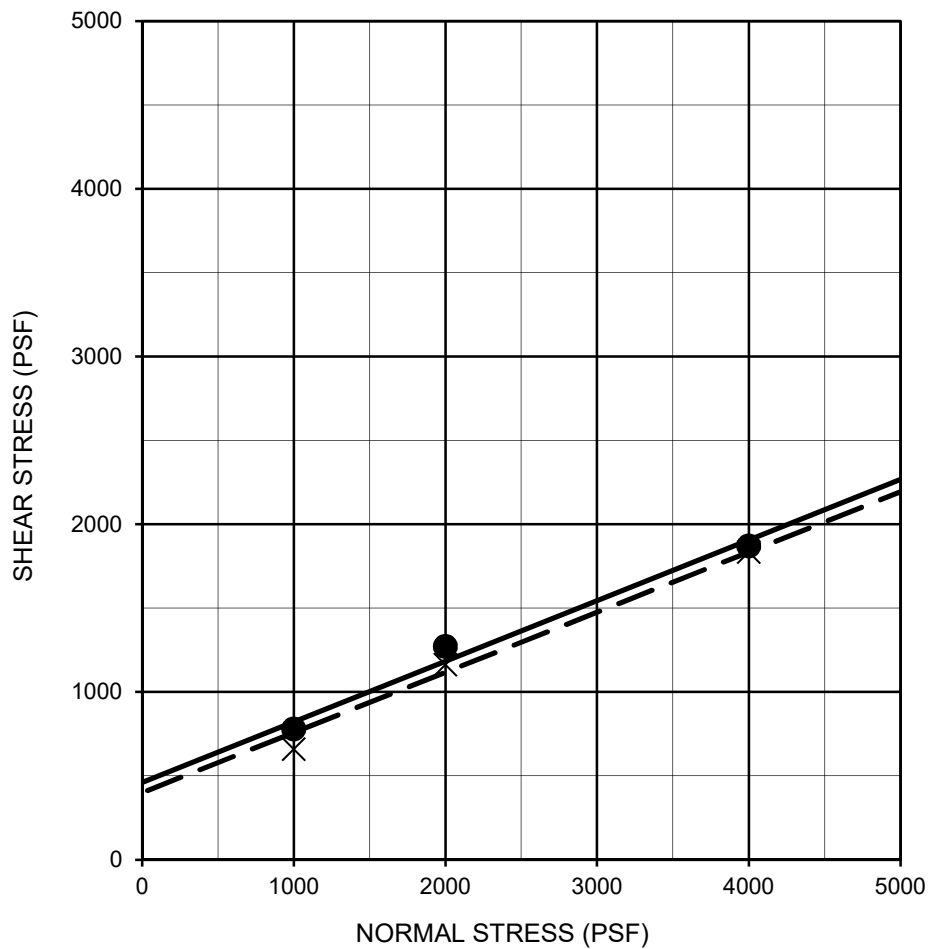
Description	Symbol	Sample Location	Depth (ft)	Shear Strength	Cohesion (psf)	Friction Angle (degrees)	Soil Type
CLAY	—●—	B-1	5.0-6.5	Peak	460	20	CL
CLAY	- - X - -	B-1	5.0-6.5	Ultimate	400	20	CL

PERFORMED IN GENERAL ACCORDANCE WITH ASTM D 3080
